ENVIRONMENTAL DUE DILIGENCE AUDIT

For the Identification of
Potentially Hazardous Materials and Conditions

Former Air Force Accounting and Finance Center
3800 York Street
Denver, Colorado

November 1994

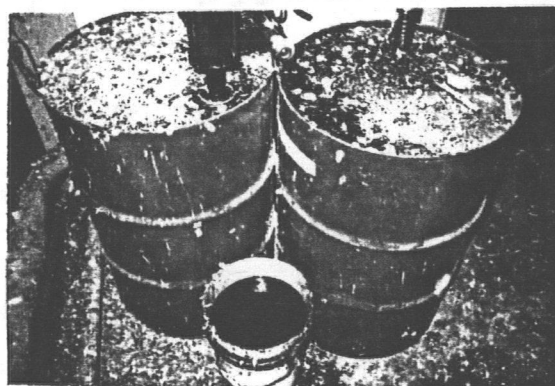
Building 4: Containers of lubricating oil inside the Steam Power House.

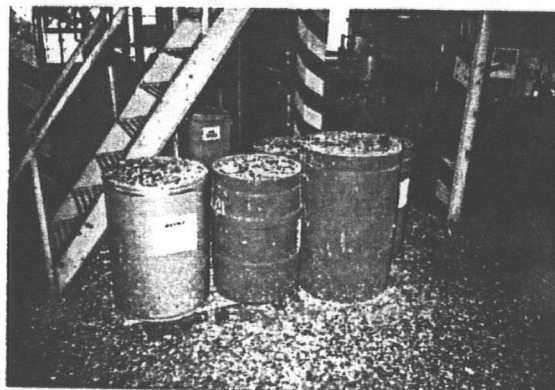
Building 4: Containers of water treatment chemicals inside the Steam Power House.

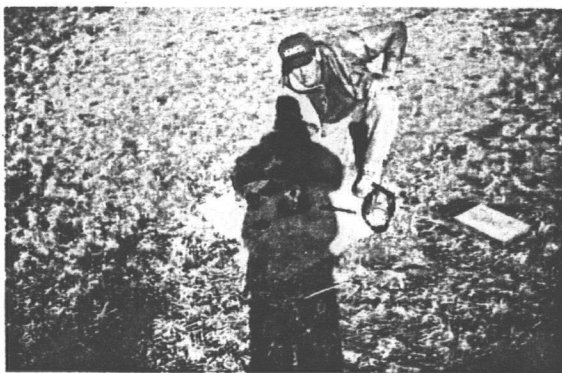
UST fill port west of Building 4.

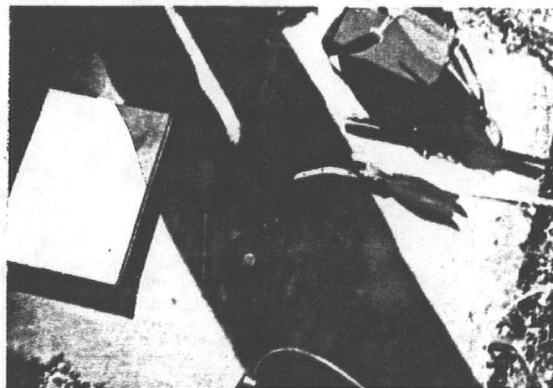
Total depth measurement of UST in tank farm west of Building 4.

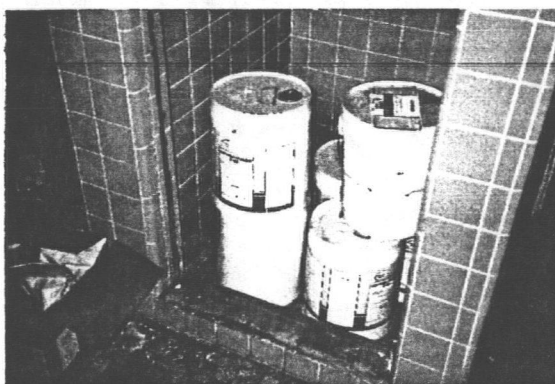
Building 1 Unit F: Containers of insecticide in bathroom.

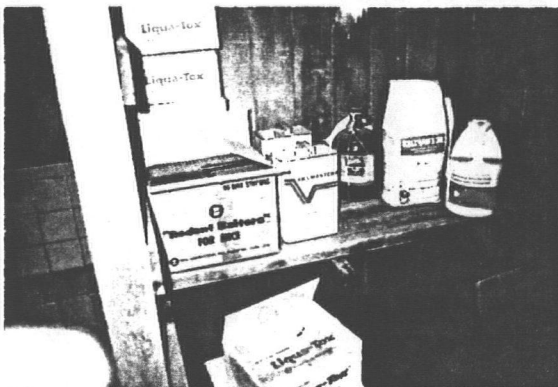
Building 1 Unit F: Containers of insecticide, personal protective equipment, cleaner, and rodent baiters in sauna in bathroom.

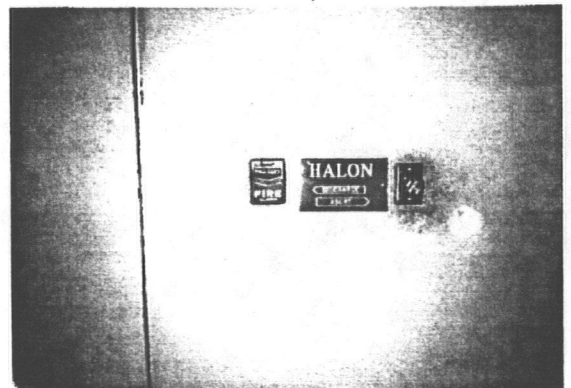
Sign identifying Halon fire extinguisher system in Building 2 computer rooms.

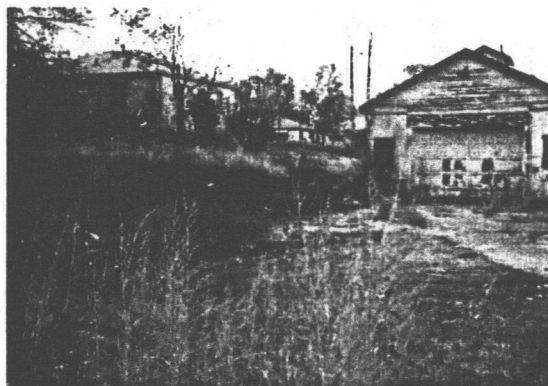
Wooden storage buildings located south of Building 1.

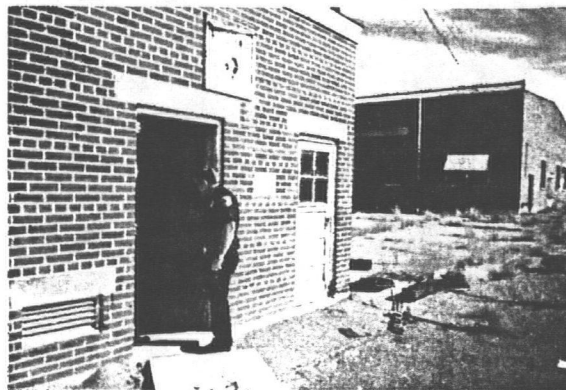
Building 9 (foreground) and Building 8 (background).

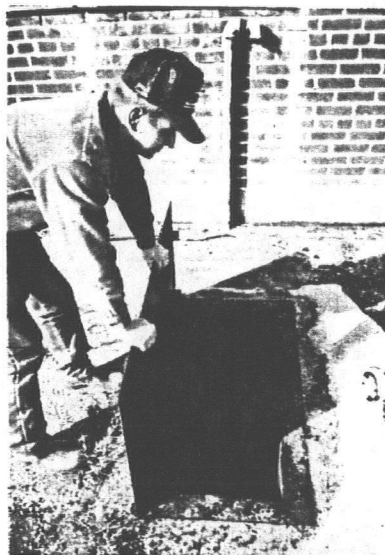
Oil trap outside east wall of Building 8.

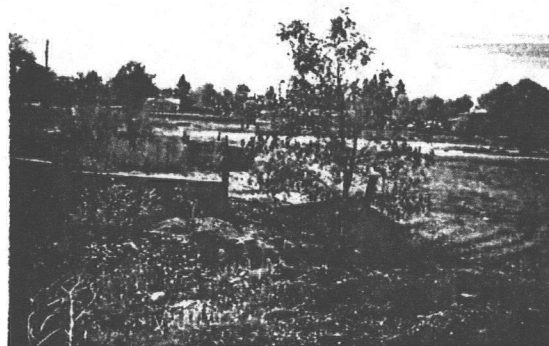
Asphalt mounds (foreground) and storage bins on southeast portion of property suggest possible former landfill.

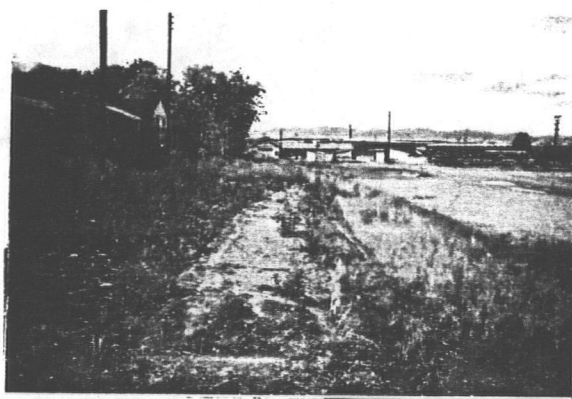
Southeast portion of the property. Note single family residences south of the property.

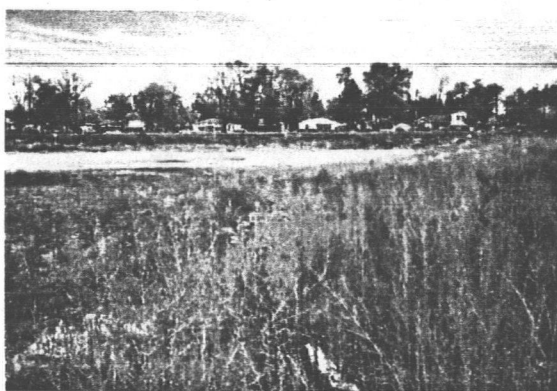
Southeast portion of the property. Note single family residences east of the property.

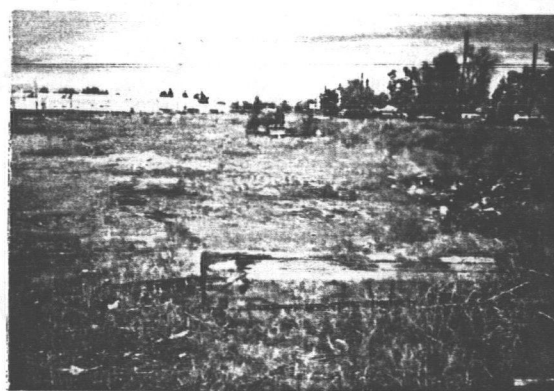
Southeast portion of the property. Photograph looking north along the east perimeter of the property. Note single family residences east of property and industrial building north of the property.
